# High Performance Sport NZ

## Sailing Safety

### Background

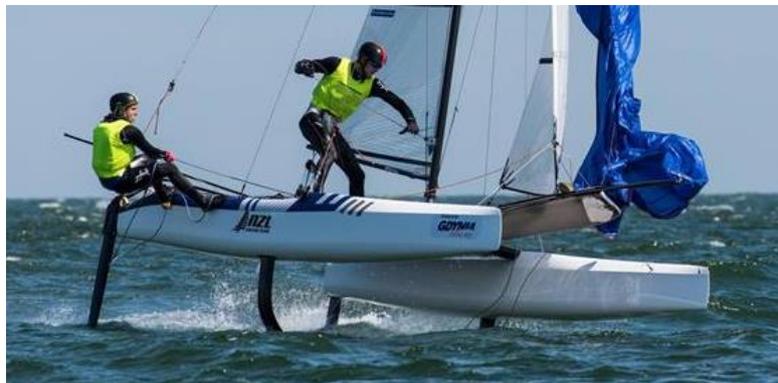
In Olympic sailing there is, over time, a clear thrust to embrace the recent rise in the use of 'foiling' technologies to move the sport forwards. In the first example of this, which may well grow over subsequent Olympic cycles, the Nacra class catamaran has been updated for the 2020 cycle to move to a foiling design. Fig. 1 below shows this design in action on the water.

Fig. 1 – A Nacra 17 foiling

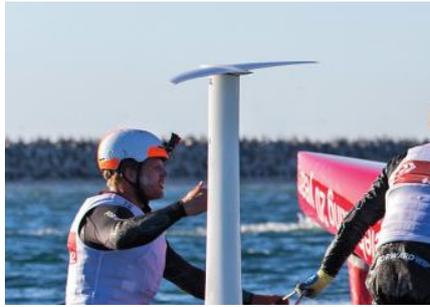
The change in design required adding a lifting element to the rudder at the back of the boat. This was done by using what is known as a T-foil design, which can be seen in Fig. 2 when the boat is inverted.

Fig. 2 – A T-foil

Over time it has become clear how this has significantly increased the risk of injury to the athlete. A typical injury mechanism is simply that of an athlete falling off the boat, into the water, being slowed by the drag of the water and being struck by the horizontal lifting element of the rudder as the boat passes.

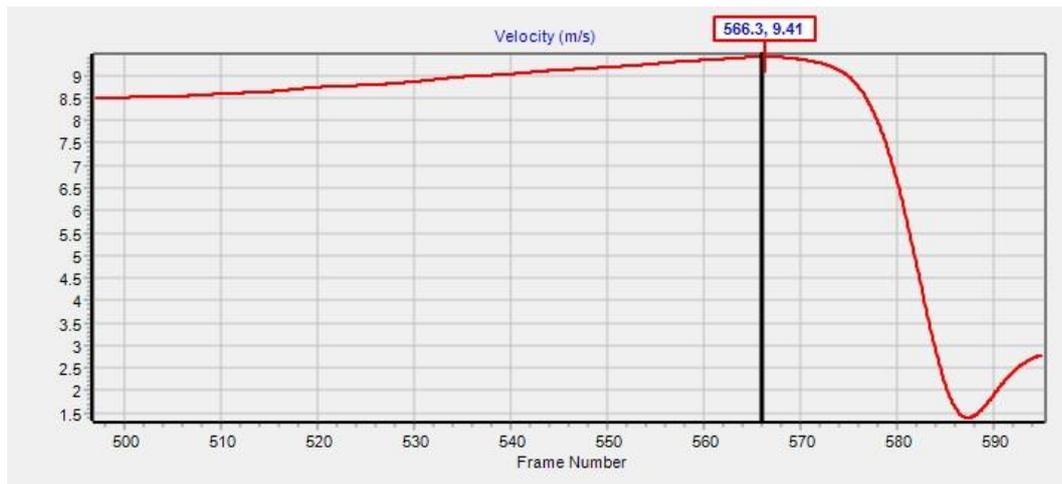
A typical speed trace is shown below in figure 3.

Figure 3 – Quintic Biomechanics (Linear Analysis)

Using Quintic in this application gave us not only a measure of speed, but also (given the fact the video is synched to the data) a visual check on where this speed had occurred through the impact. This was achieved in near real time during testing using a single automatically tracked marker on the dropping rudder element, which can be seen in some of the photos overleaf.

The benefit of this approach was to allow review of this key metric of the test while the equipment was being re-set for the next test. Thus, any poor tests could be flagged and repeated as required.

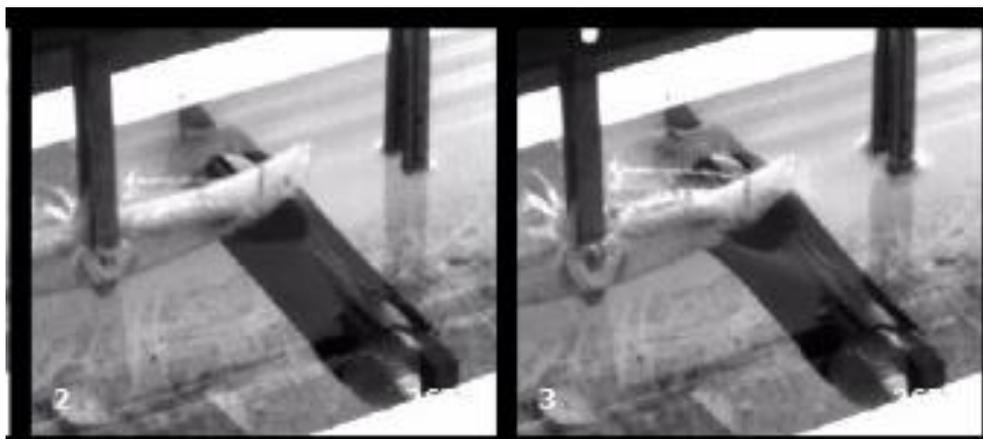
In Figures 4 and 5 below examples of the two different tests are shown. The results of the slicing tests were taken and used to select the material for construction of our safety equipment for the sailors this cycle and the full impact tests strengthened YNZ communications to the class around these concerns. It is now likely the design will change post Tokyo 2020 Olympics.

Figure 4 – A 'slicing' test

Two damage mechanisms were investigated – essentially to replicate a glancing slice from the relatively sharp leading edge of the lifting element and a full-blown impact. The clothing impact work was mainly concerned with the slicing action and the full impact was used mainly to feedback to the class committee around the risks involved.

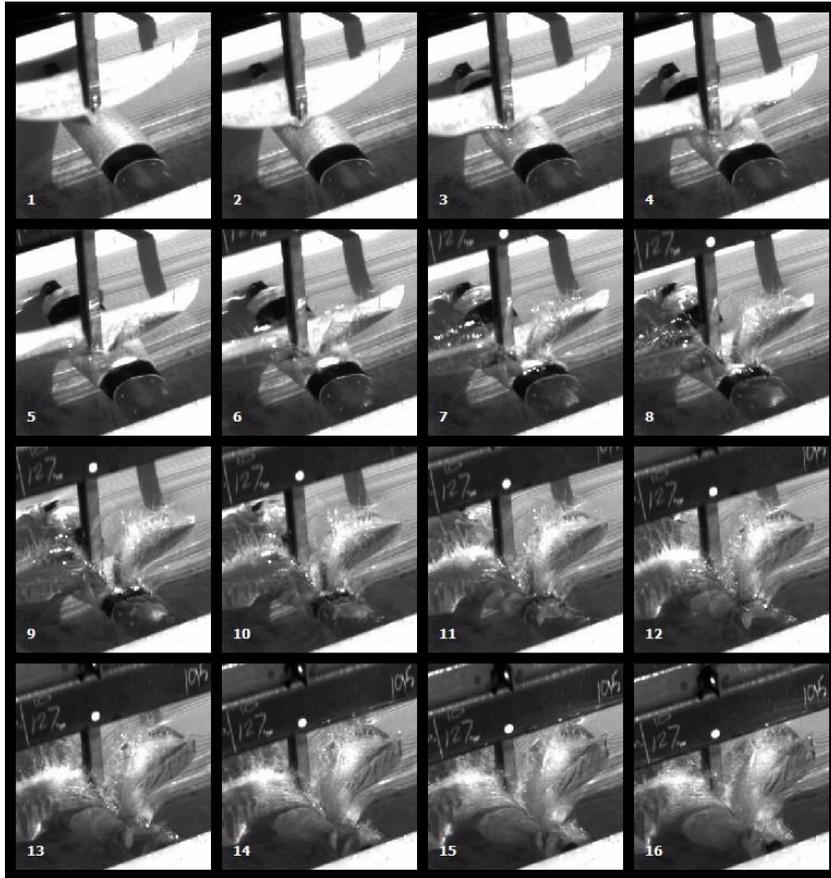
Figure 5 – Storyboard of a full 'impact' test
